National Transportation Safety Board

Investigative Update of Battery Fire Japan Airlines B-787 - Jan 7, 2013

February 7, 2013

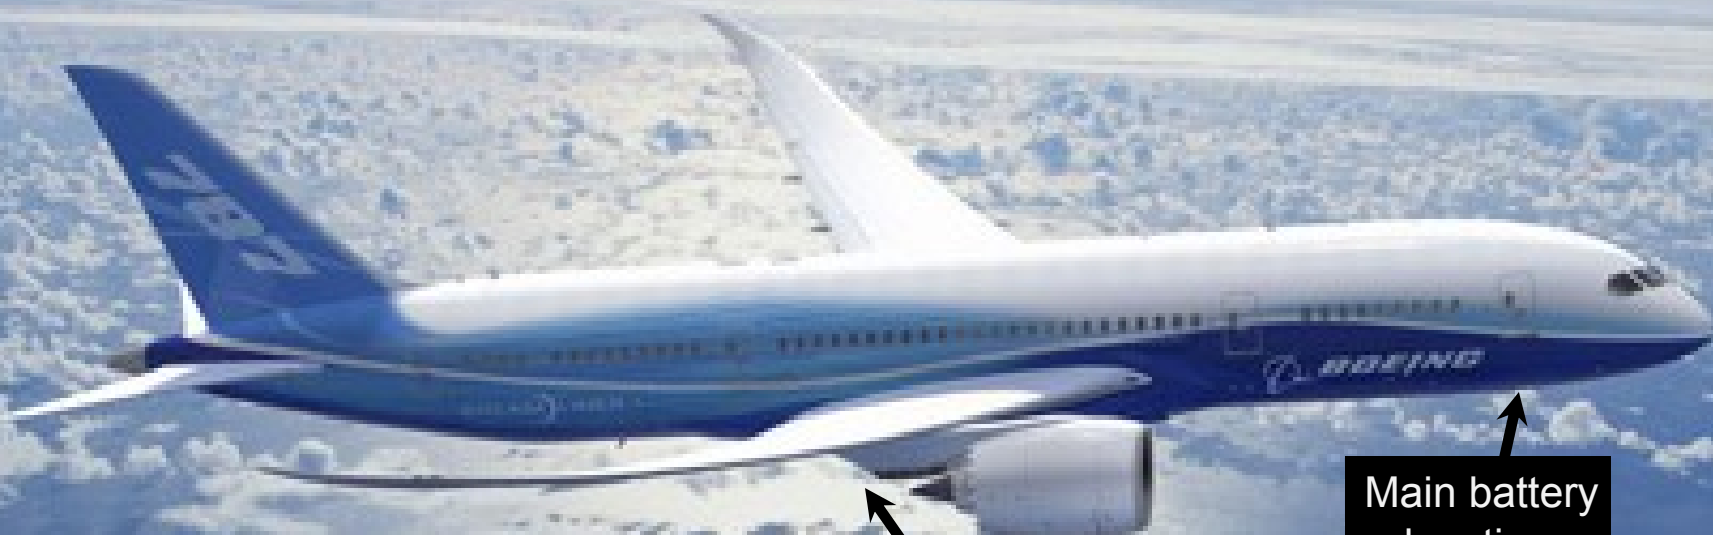
Auxiliary Power Unit (APU)
battery location

Main battery
location

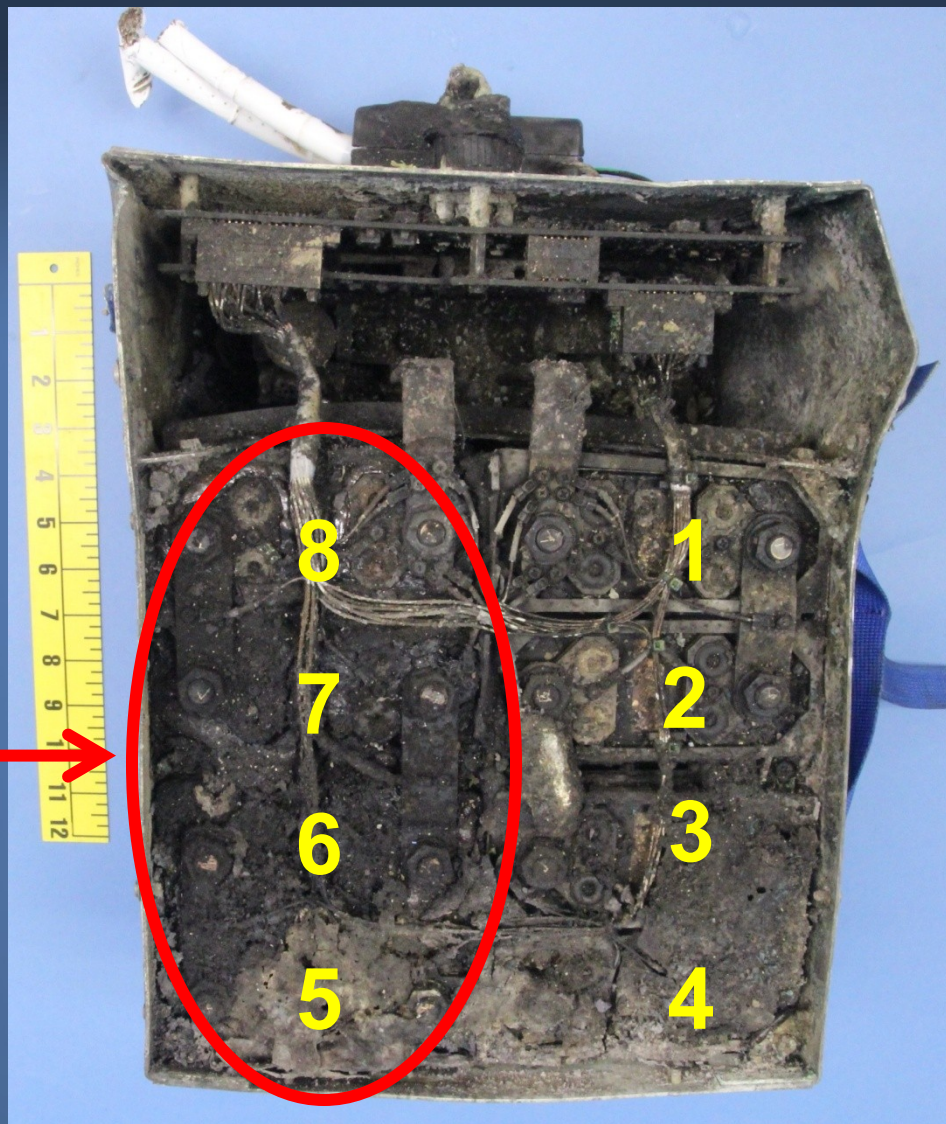
Thermal Damage

Area of most thermal damage

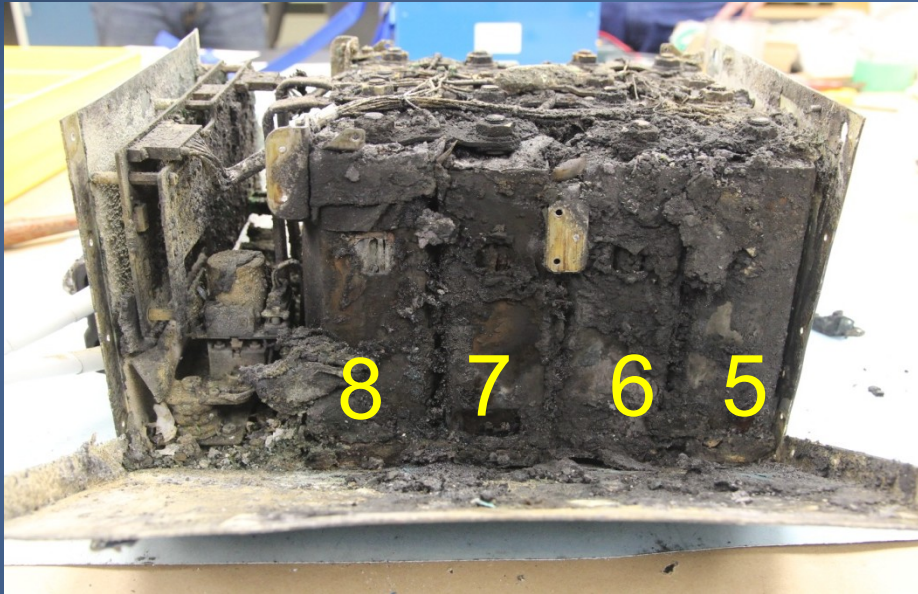
Cells on the left side

Substantial thermal damage

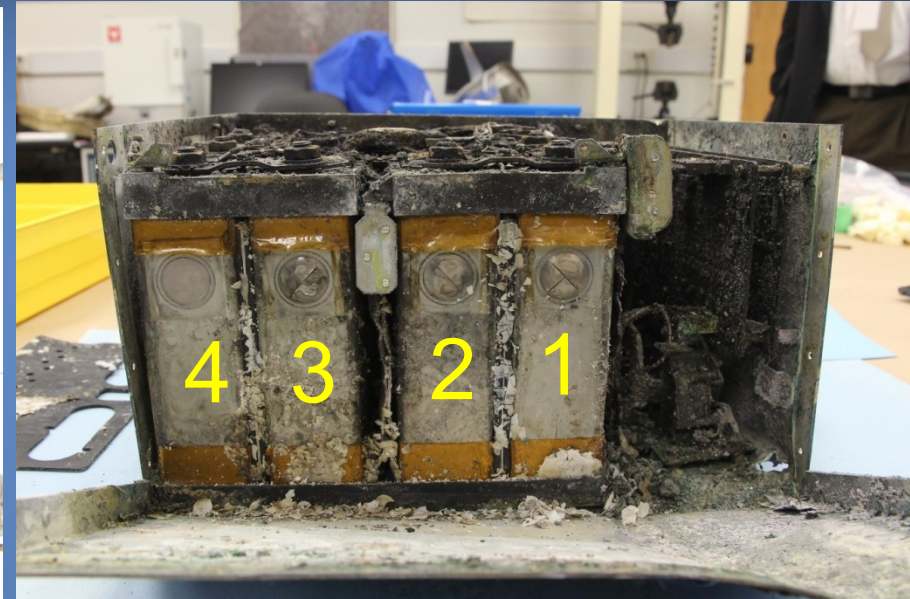
Cells on the right side

Moderate thermal damage

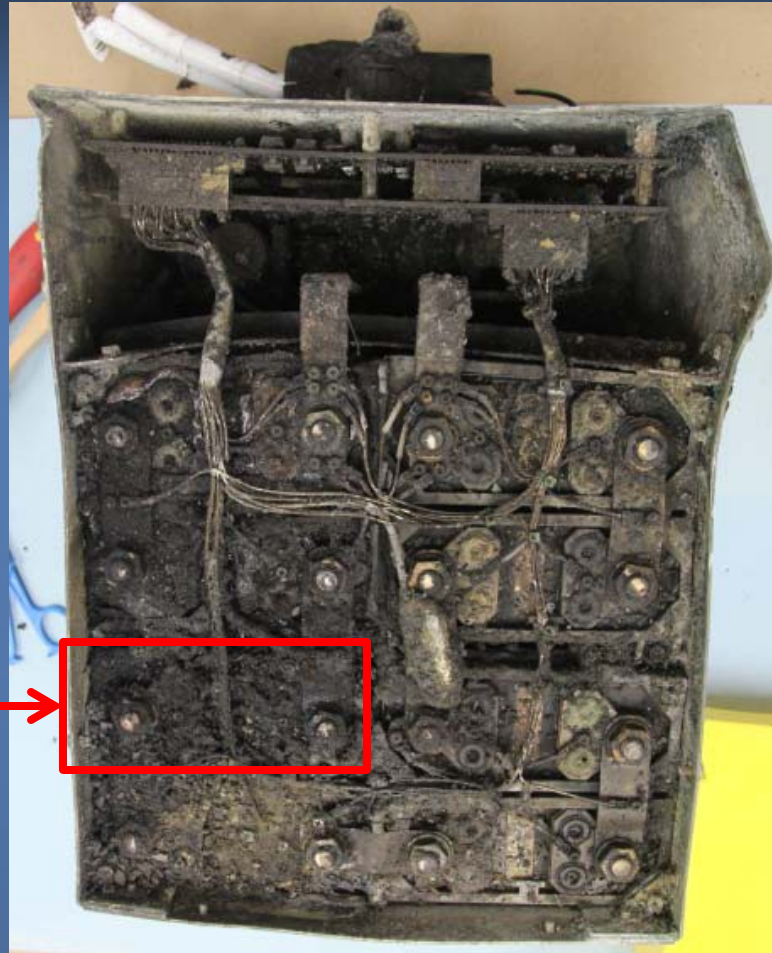
Focus on Cell #6

Cell #6

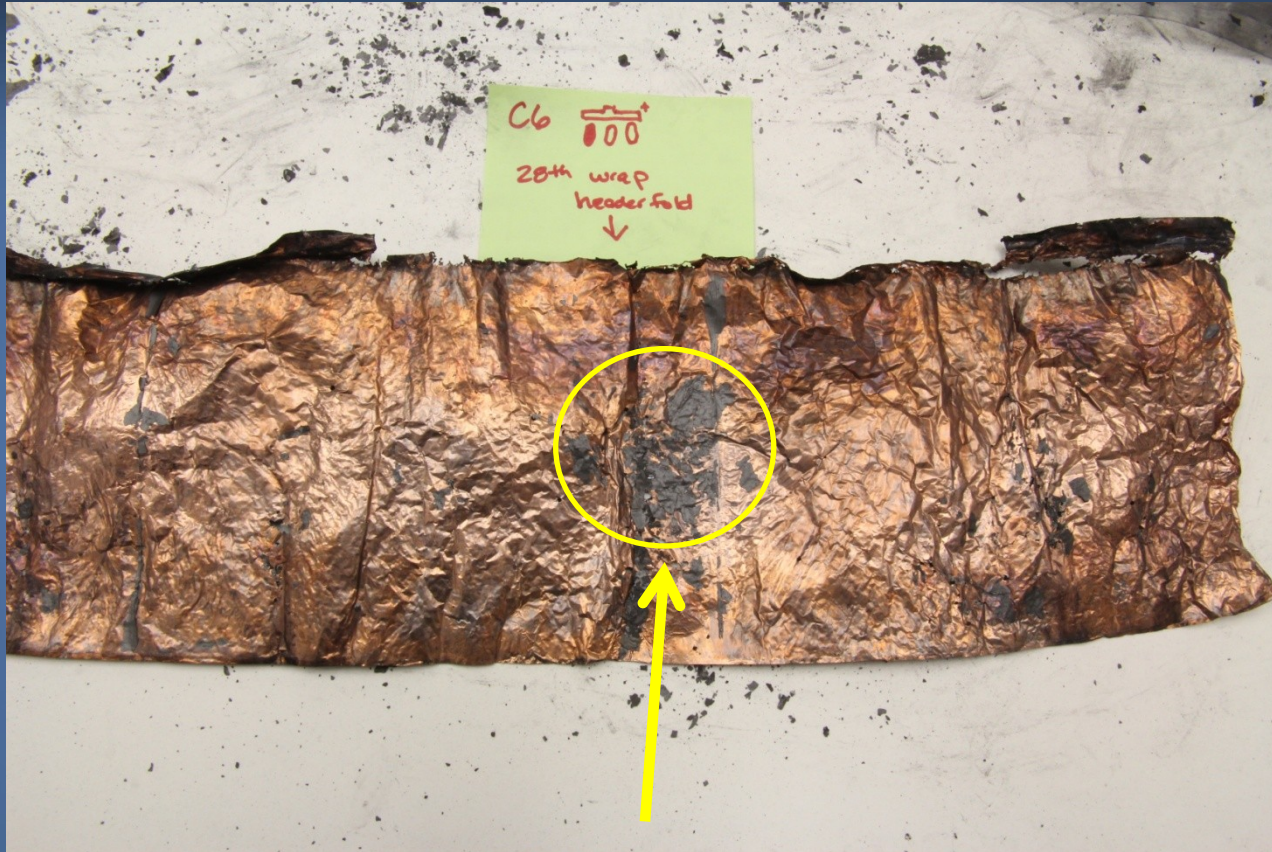
Damaged electrode in Cell #6

Hot Spot

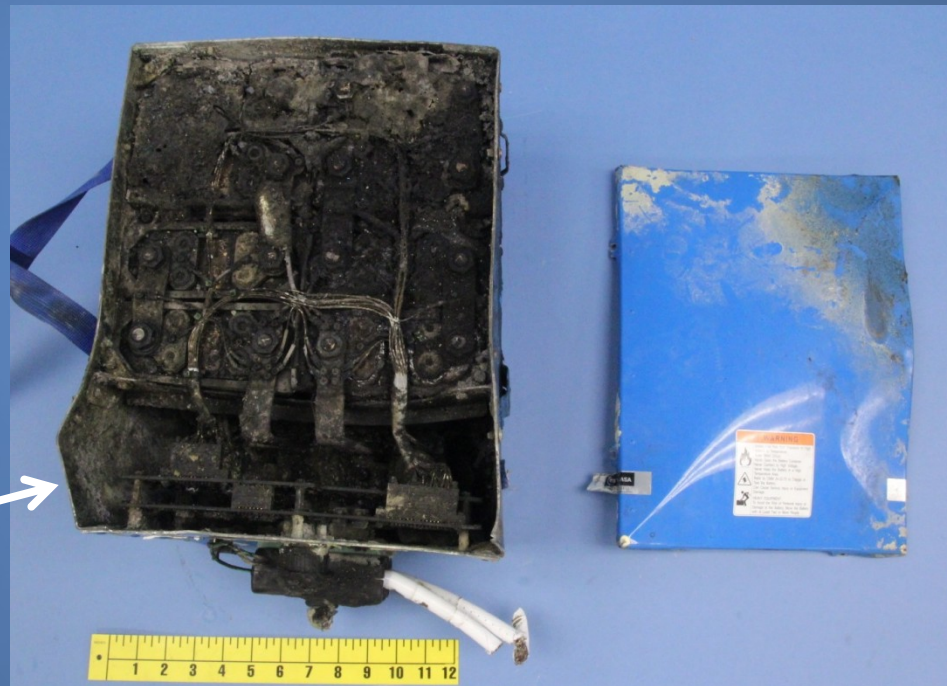
- Mechanical impact damage

Damage from
firefighting
efforts

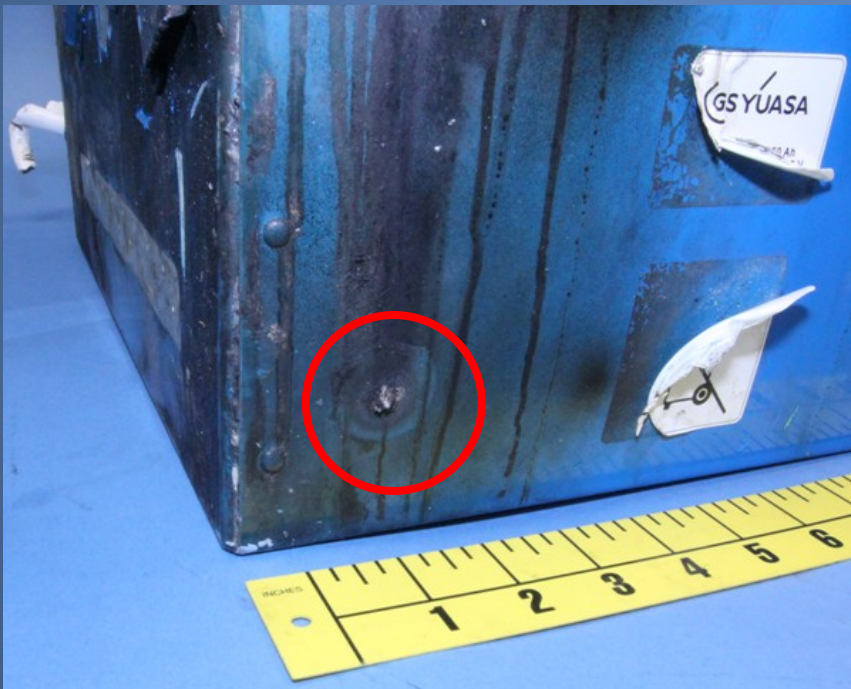
- External short circuit of cell or battery
