# **Accident Report**

Tadahiko Mizuno Division of Quantum Energy Engineering, Research group of Nuclear System Engineering Hokkaido University E-mail: mizuno@qe.eng.hokudai.ac.jp

On January 24, 2005 at around 4:00 p.m. an explosion occurred during a plasma electrolysis experiment being performed by Mizuno in the Quantum Energy Engineering Section.

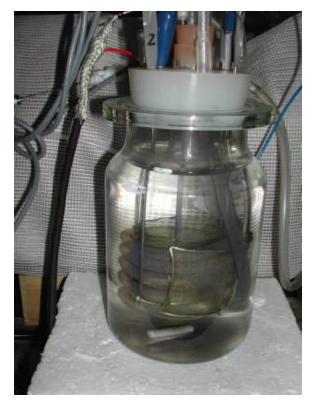
The cell was a 1000 cc Pyrex glass vessel which has been in use for about 5 years. It contained 700 cc of  $0.2M \text{ K}_2\text{CO}_3$  electrolyte; a platinum mesh anode; and a tungsten cathode wire 1.5 mm in diameter, 29 cm long, with 3 cm exposed to the electrolyte. Electrolyte temperature was 20 deg C. The cell was placed inside a constant temperature air-cooled incubator (Yamato 1L-6) with the outer door open, and the inner Plexiglas safety door closed. The experimental setup is described in Ref. 1 and cells are shown in Fig. 1 and 2. The event occurred in the early stage of the experiment before a plasma normally forms. Soon after ordinary electrolysis began, voltage was increased to 20 V and current to 1.5 A. 5 or 6 seconds later, a bright white flash was seen on the lower portion of the cathode. The light expanded and at the same instant the cell exploded.

Figure 1. A glow discharge cell. Photo taken in 2003 by T. Mizuno

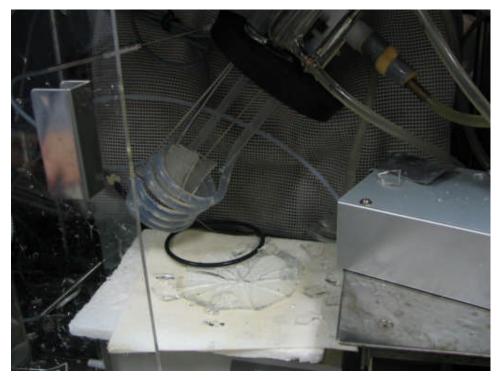
The explosion blew open the Plexiglas safety door and spread shards of Pyrex glass and electrolyte up to  $5 \sim 6$  m into the surrounding area.

The vessel was old and may have had a scratch on the inner surface.

The effluent hydrogen and oxygen were mixed in the cell headspace. There  $2 \sim 3$  cc of hydrogen at the time, although this is an open cell so only minimal amounts of gas remain in the headspace.

It is possible that the tungsten cathode may have been exposed to the gas in the headspace.

Figure 2. Remains of glow discharge cell after explosion. Photo taken in 2005 by T. Mizuno.

Perform experiments under remote control, with power supplies and meters placed a safe distance from the cell.

Use an explosion-proof cell vessel and equipment chamber.

Do not use glass cells. (We are now investigating alternative materials.)

All glass and plastic vessels should be wrapped with filament tape to prevent fragmentation.
